Contract #: 04-0120F4Cty: SF/ALA Rte: 80 PM: 13.2/13.9File #: 13.28**WELDING INSPECTION REPORT****Resident Engineer:** Pursell, Gary**Address:** 333 Burma Road**City:** Oakland, CA 94607**Report No:** WIR-007143**Date Inspected:** 10-Jun-2009**Project Name:** SAS Superstructure**OSM Arrival Time:** 1400**Prime Contractor:** American Bridge/Fluor Enterprises, a JV**OSM Departure Time:** 2230**Contractor:** Oregon Iron Works Clackamas, Or.**Location:** Clackamas, OR**CWI Name:** Steve Barnett**CWI Present:** Yes No**Inspected CWI report:** Yes No N/A**Rod Oven in Use:** Yes No N/A**Electrode to specification:** Yes No N/A**Weld Procedures Followed:** Yes No N/A**Qualified Welders:** Yes No N/A**Verified Joint Fit-up:** Yes No N/A**Approved Drawings:** Yes No N/A**Approved WPS:** Yes No N/A**Delayed / Cancelled:** Yes No N/A**Bridge No:** 34-0006**Component:** Hinge-K Components**Summary of Items Observed:**

Summary of Items Observed: On this date, Caltrans Quality Assurance Inspector (QA) Clete Henke was present at Oregon Iron Works, Inc. (OIW) in Clackamas, OR for observation of fabrication of the Hinge K Pipe Beams and related activities including in process welding and OIW Qualit

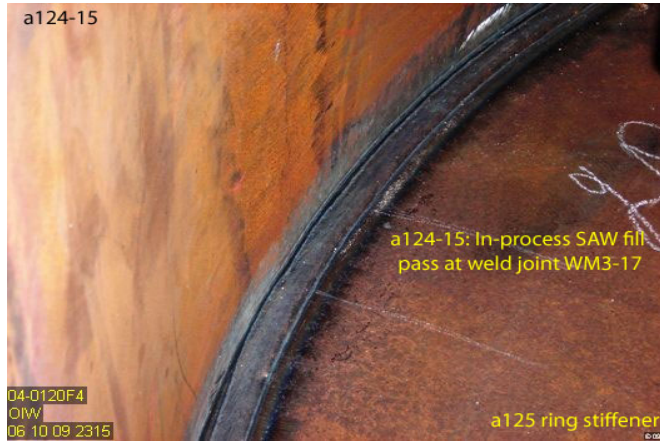
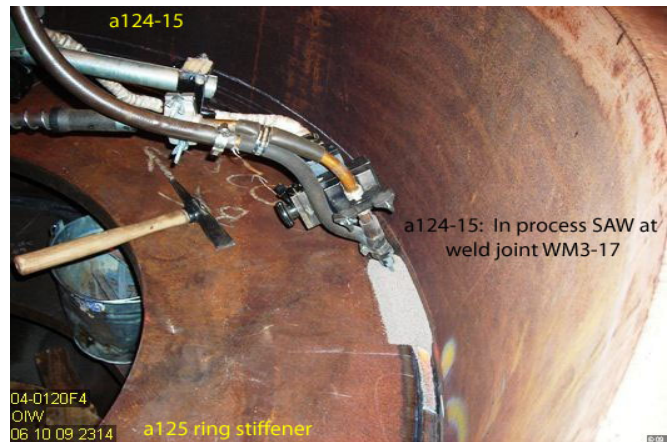
The QA Inspector intermittently monitored OIW welder Mikhail Bannikov (WID B28) during in progress Submerged Arc Welding (SAW) at weld joint WM3-17 joining a125 stiffener ring to a124-15 Fuse Section. The QA Inspector observed as OIW QC Inspector Steve Barnett performed Magnetic particle Testing (MT) and Visual Inspection (VT) of completed root passes at weld WM3-17. Mr. Barnett stated that he had located no rejectable indications. The QA Inspector subsequently performed 100% VT & 10% MT verification at the location noted above finding the root pass to be in general compliance with contract documents. Please reference TL-6028 report for this date for details. The QA Inspector intermittently observed as welder B28 continued to deposit SAW fill and cover passes in the flat (1G) position in accordance with approved welding procedure 4020. The QA Inspector noted the OIW welder was maintaining continuous preheat utilizing two torches. An OIW helper was observed assisting welder B28 during SAW process. The QA Inspector observed OIW QC Inspector Steve Barnett regularly monitoring and recording the in process SAW parameters. The QA Inspector also intermittently observed in process welding parameters and determined that the SAW parameters and minimum preheat/interpass temperature appeared to be in general compliance with the contract requirements -- (35 volts, 585 amperes,

OIW QC Inspector Steve Barnett contacted the QA Inspector and stated that he intended to conclude Ultrasonic Testing on circumferential weld joint WM3-18 on assembly 120A-4 which had been initiated on the previous day. The QA Inspector subsequently randomly observed Mr. Barnett as he completed the testing referenced above. Mr. Barnett subsequently stated that he had located one indication which would require further evaluation.

The QA Inspector intermittently observed OIW qualified welder's Bounheune Savanh (WID S74) and Vincent Vu (WID V7) during in-process pick-up welding of Soudotape 316L stainless steel overlay to hinge k pipe beam fuse sub-assembly 120A-3. The weld joint is identified as 316L 3rd layer. Mr. Savanh and Mr. Vu were observed grinding low spots on completed 316L 3rd layer and subsequently welding the excavated low spots in the flat position utilizing automatic electro slag welding (ESW) overlay process with a .5mm x 60mm Soudotape 316L stainless electrode, filler metal brand Soudotape class EQ316L automatic. The QA Inspector observed OIW QC Inspector Steve Barnett regularly monitoring and recording the in process ESW parameters. The QA Inspector also intermittently observed in process welding parameters and determined that the ESW parameters (1175 amps, 26 volts, 254mm/min travel speed) and minimum preheat temperature of 70° F appeared to be in general compliance with the contract requirements and approved OIW Welding Procedure Specification (WPS) 7003.
